NRHEG SCHOOL DISTRICT

2017 Facility Assessment

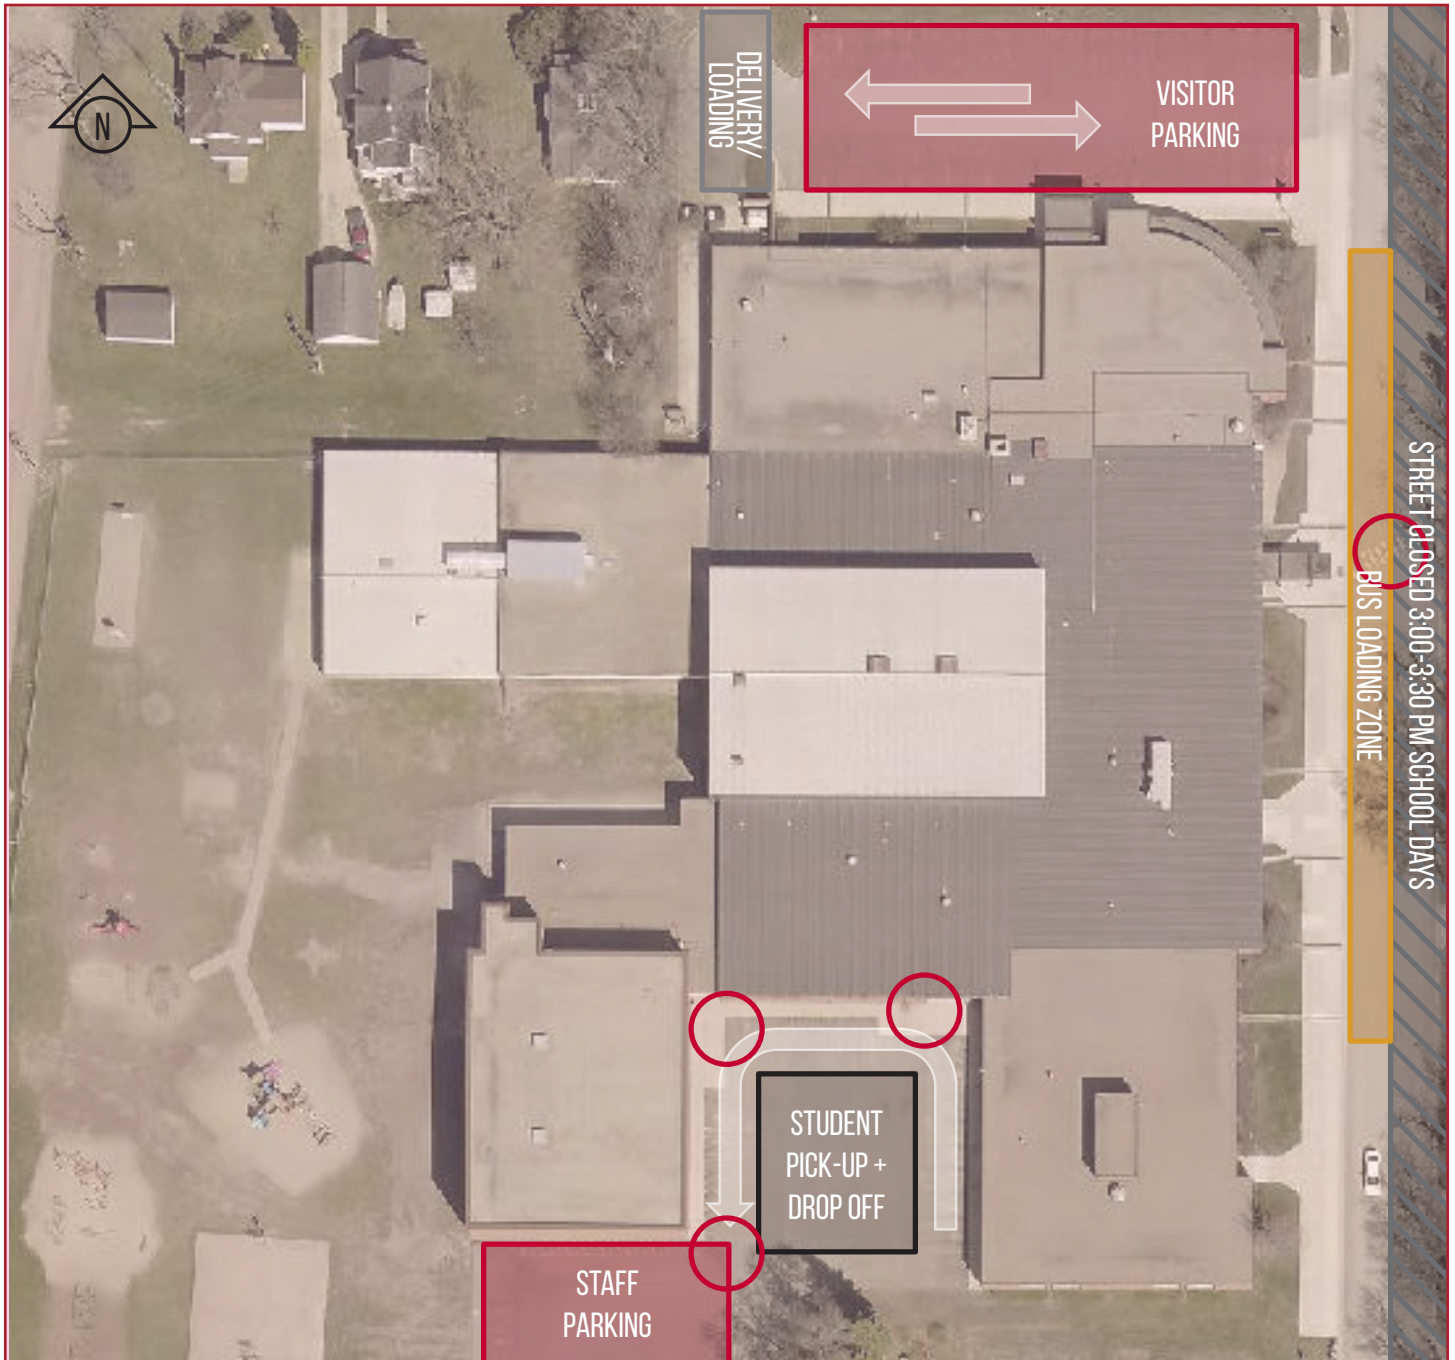
Figure 1 - Cracked sidewalk near loading sign

Figure 2 - Cracked sidewalk near door 1N

Figure 3 - Cracked sidewalk near door 6S

The adjacent concrete sidewalks provide access to the building. The sidewalks are generally in good condition, however there is minor cracking along the edges and discoloration near the roof drain leaders. Six broken sidewalk panels are located between doors 6S and 7S. The sidewalks are a “turn-down” style and are not wide enough to allow for an accessible 4’ path when accounting for a 2’ vehicle overhang.
