NRHEG SCHOOL DISTRICT

2017 Facility Assessment

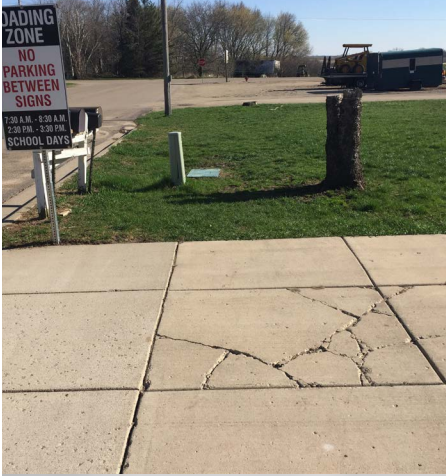
Figure 1 - Cracked sidewalk near loading sign

The adjacent concrete sidewalks provide access to the building. The sidewalks are generally in good condition, however there is minor cracking along the edges and discoloration near the roof drain leaders. Six broken sidewalk panels are located between doors 6S and 7S. The sidewalks are a “turn-down” style and are not wide enough to allow for an accessible 4’ path when accounting for a 2’ vehicle overhang.

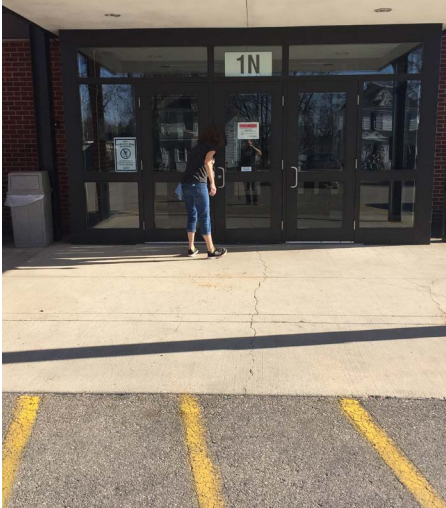
Figure 2 - Cracked sidewalk near door 1N

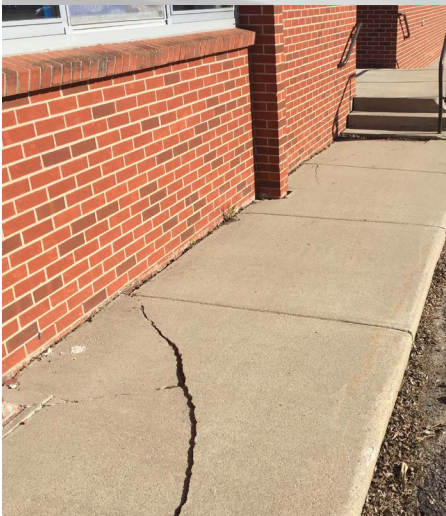
Figure 3 - Cracked sidewalk near door 6S

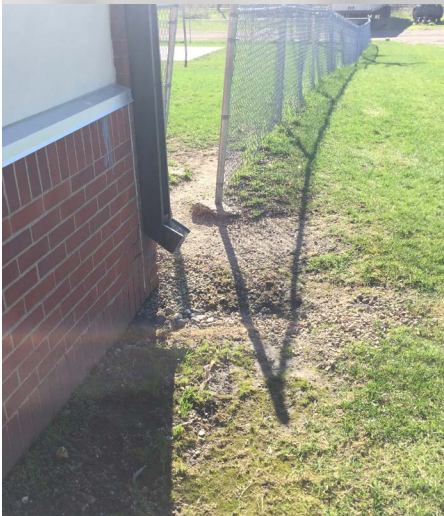
Figure 8 - Playground fence and erosion

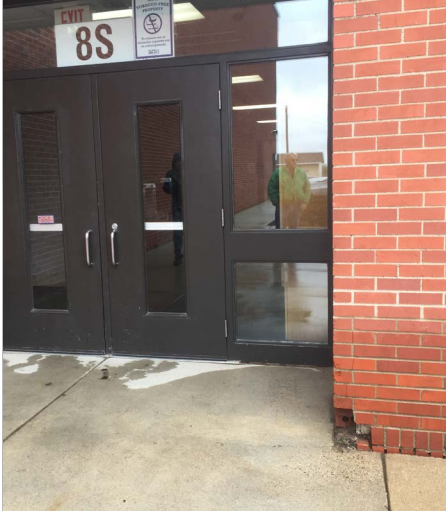
Figure 1 - Damaged/missing bricks at corner

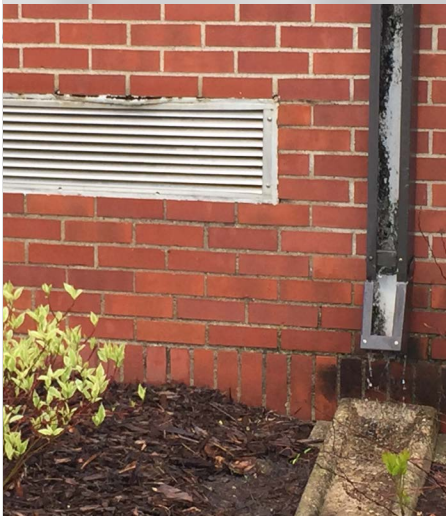
Figure 2 - Grille that could be removed

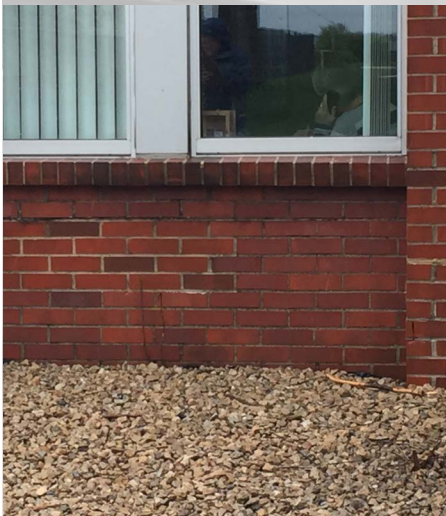
Figure 3 - Area in need of tuckpointing

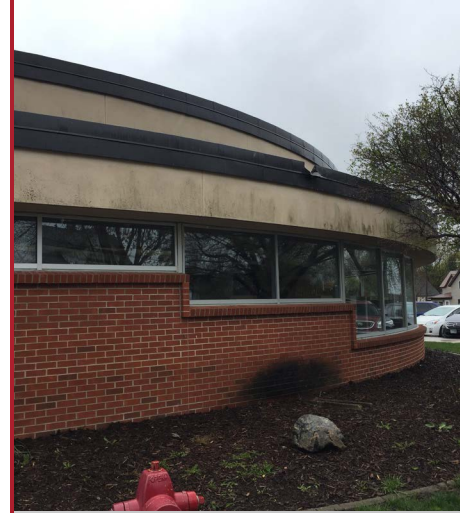
Figure 4 - EFIS surface in need of cleaning

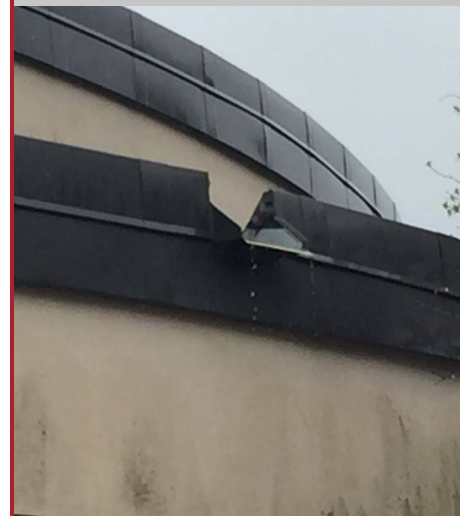
Figure 5 - Close up of EFIS surface

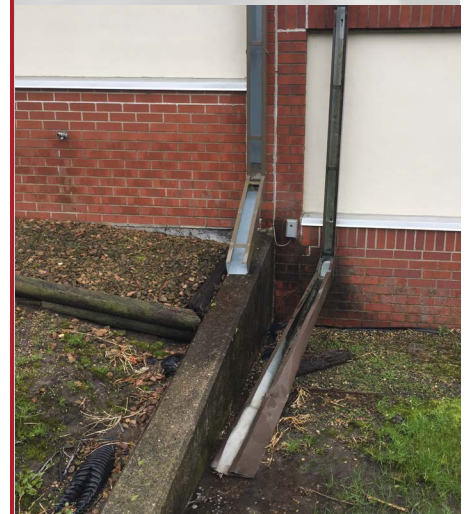
Figure 6 - Poor storm drainage management

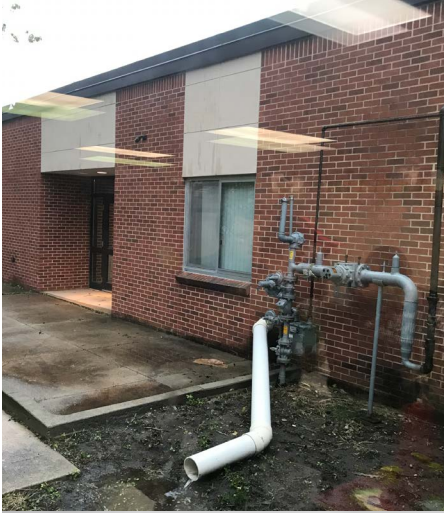
Figure 7 - Pipe on roof drain to direct water away from building

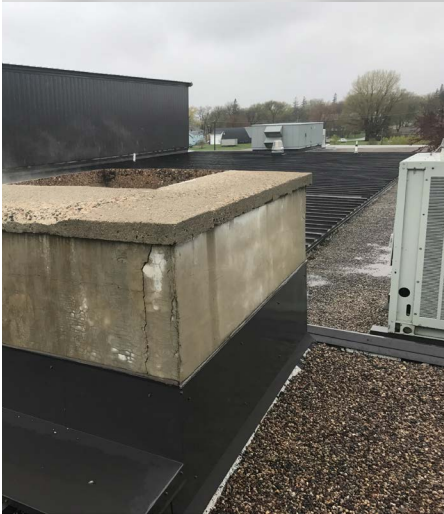
Figure 8 - Damaged cap flashing

The roof flashing at the end of the C Wing should be replaced, as well as the corner flashing outside Door 12W. No chimney cap is present and some masonry cracking was observed, both of which should be repaired/replaced to protect against water intrusion issues. The gutters in the C wing have debris and should be cleaned. The debris is a result of a tree overhanging the roofline, and the tree should be trimmed to avoid unnecessary organic matter collecting into the gutters in the future.

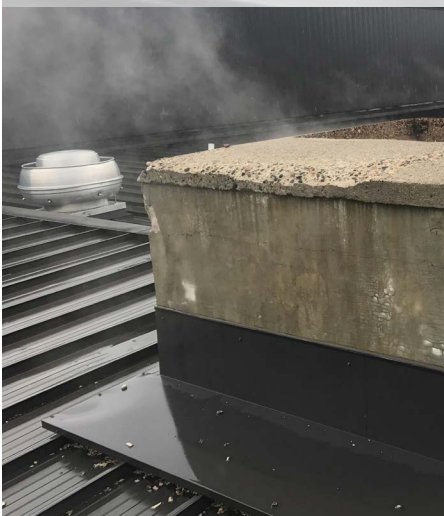
Figure 9 - Damaged Cap flashing

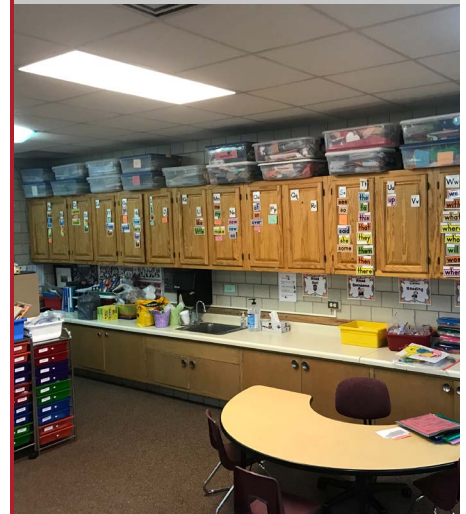
Figure 2 - Classroom casework and sink

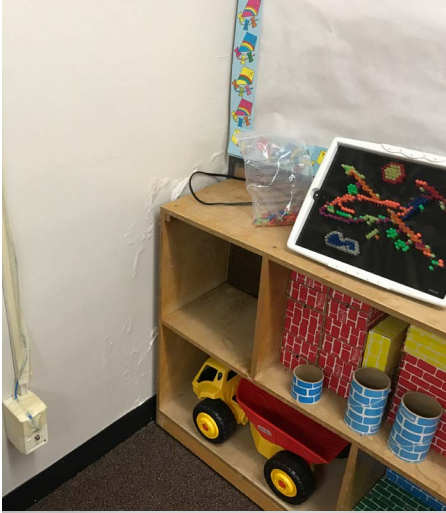
Figure 4 - Damage adjacent to casework

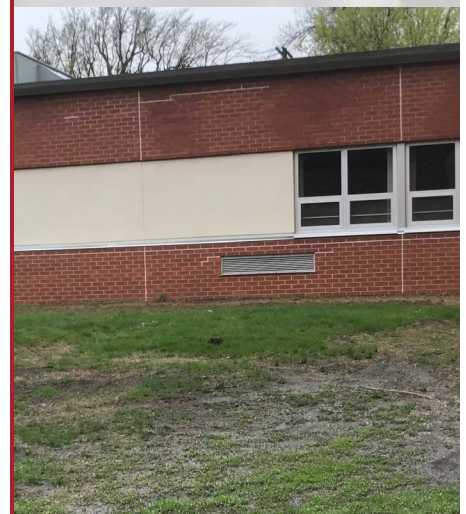
Figure 3 - White streaks in the brick which indicate previous tuckpointing attempts

Exterior walls require some tuckpointing and caulking. While this is not an immediate structural concern, if deferred too long, moisture that enters the wall cavities as a result of poor brick conditions or failed sealants and can start to erode the brick along with other structural members and systems. Should moisture penetration occur, damage usually goes unnoticed until some major sign of a problem or event occurs. At that point, repairs are usually costly. ISG always recommends that moisture is controlled to a high degree to protect the integrity of the building.

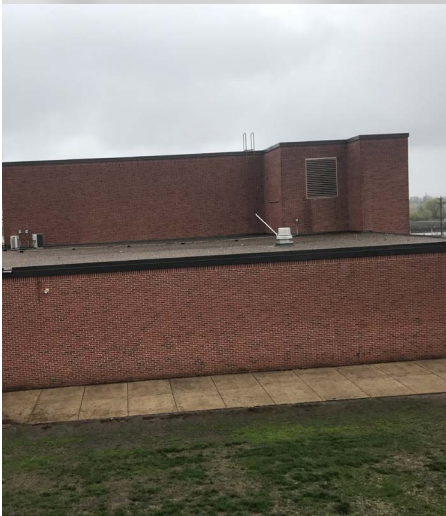
On the roof area by the Southwest gym a plumbing roof vent has been extended. This is usually an indication that heavy snow drifting is occurring in that area. During winter conditions these roofs should be monitored after heavy snow falls. Deflection of the

Figure 5 - Extended plumbing roof vent

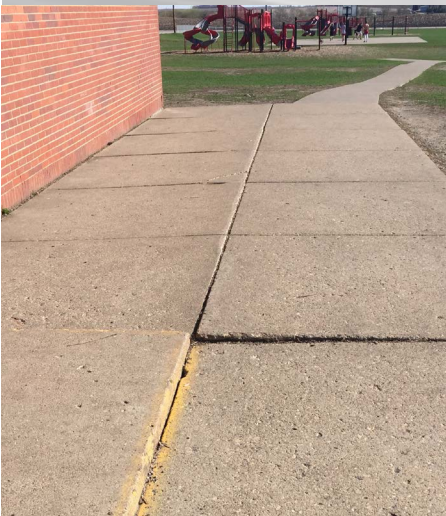
Figure 6 - Sidewalk settlement due to inadequately-compacted backfill

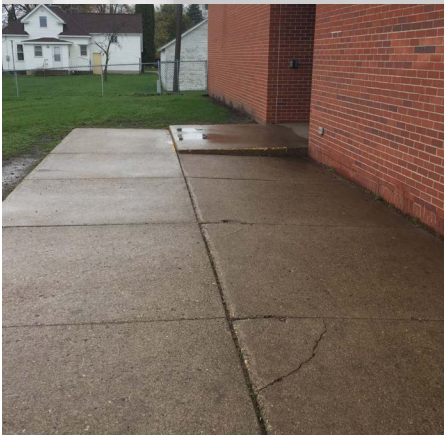
Figure 3 - Cracked sidewalk and 1-inch lip at sidewalk edge, creating accessibility issues

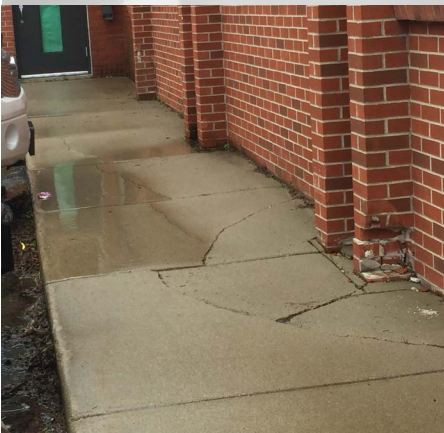
Figure 4 - Cracks in sidewalk

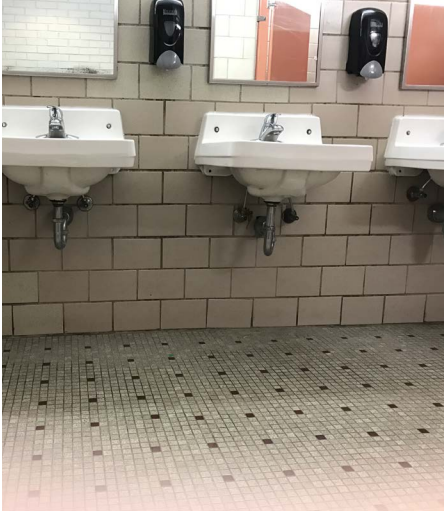
Figure 1 - Restroom sinks which do not meet current ADA standards

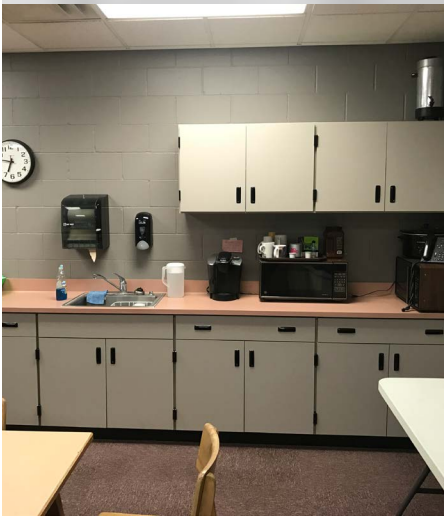
Figure 2 - Typical classroom sink which is not ADA compliant

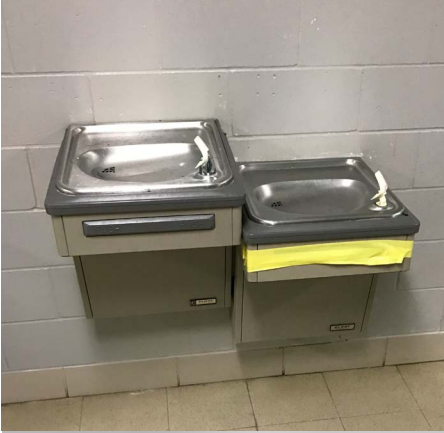
Figure 4 - Broken electric water cooler

Replace inoperable urinal flush valve in men's locker room			●
Repair water source to center sink in men's locker room			●
Install pipe wrap on P-traps in men's locker room			●
Replace leaking shower head in men's locker room			●
Replace water closet flush valve in men's locker room office restroom			●
Verify roof drain in gym does not leak, and insulate roof drain pipe			●
Verify roof drain in cafeteria does not leak, and insulate roof drain pipe			●
Replace electric water cooler in area E hallway			●

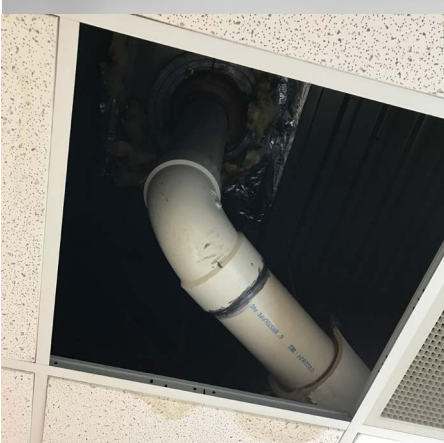
Figure 5 - Uninsulated roof drain

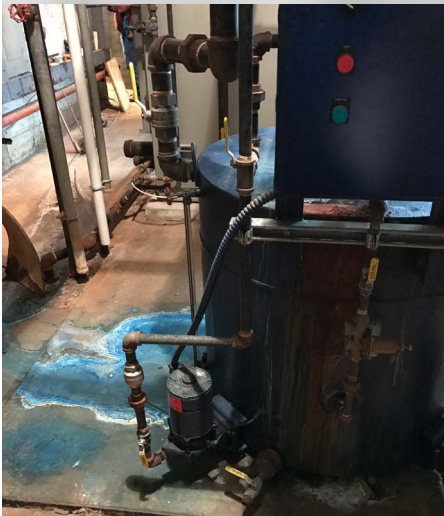
Figure 2 - Leaking boiler feed unit

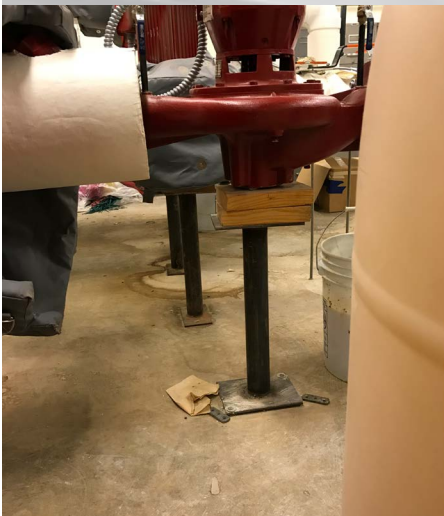
Figure 3 - No vibration isolation on pumps

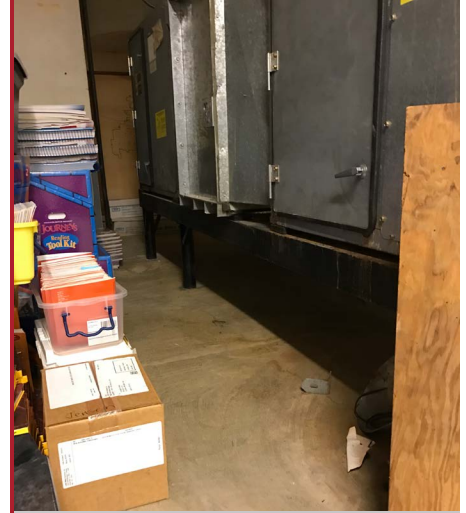
Figure 4 - No vibration isolation on AHU

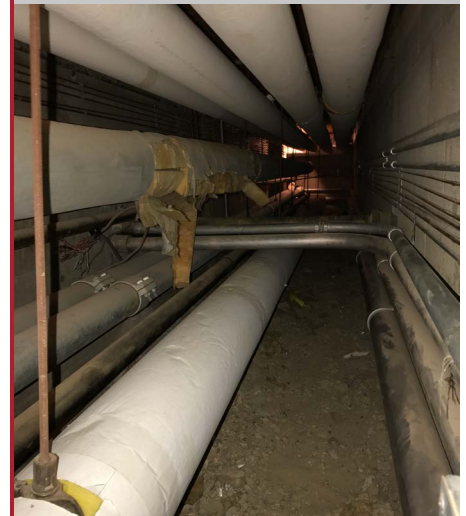
Much of the existing piping above the ceiling in the cafeteria (A117) is in poor condition. A lot of the piping in the tunnel space near the old workshop had insulation that was falling off of the pipe.

Figure 5 - Insulation falling off in tunnels

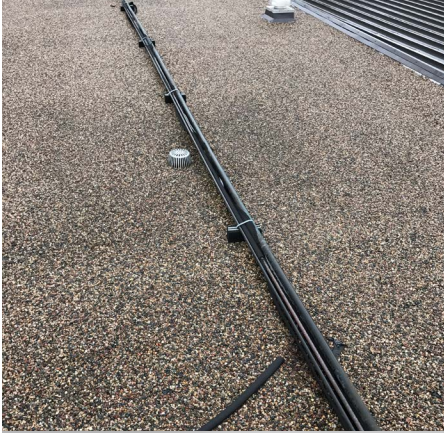
Figure 7 - Missing insulation on refrigerant lines

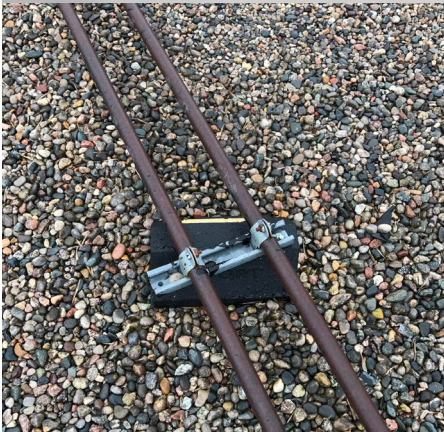
Figure 8 - Broken gas pipe supports

- ✓ Replace louvers have been damaged. The louvers no longer in use should be removed or capped on the backside to ensure no water can leak into the building.
- ✓ Review controls sequence should be reviewed. The cooling coil in the rooftop units come after the heating coils. This order should be reversed to allow for extra dehumidification.
- ✓ Re-insulate pipe on roof and ensure proper support.

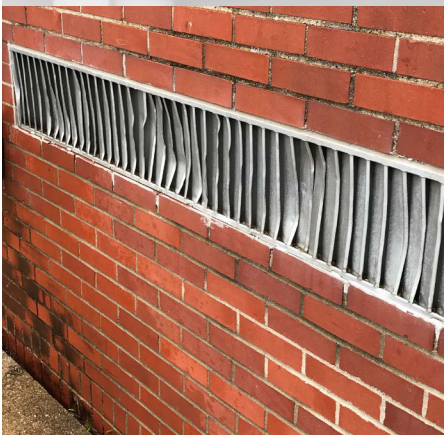
Figure 9 - Damaged intake louver

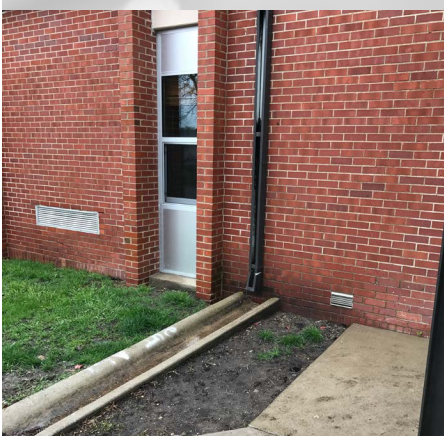
Figure 10 - Leaking abandoned louver

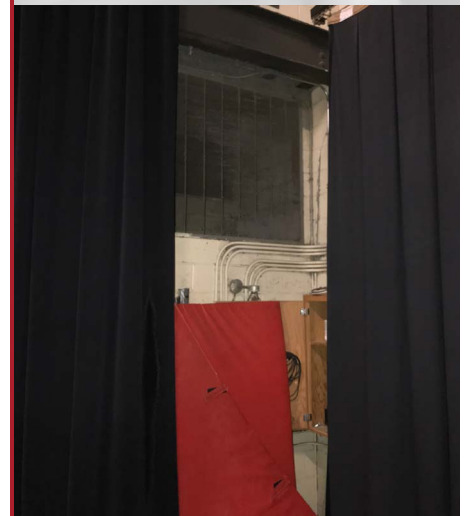
Figure 13 - Space lacking air return

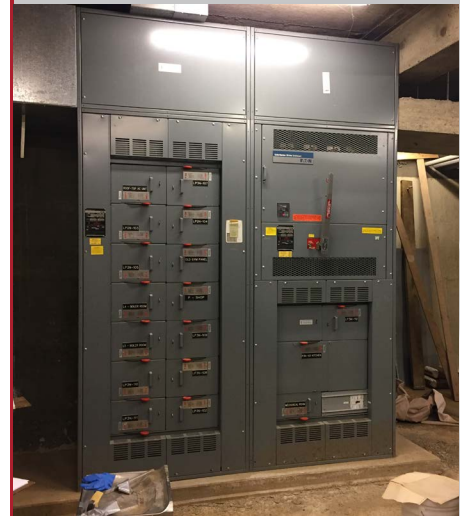
Figure 2 - Main electrical gear

The main electrical gear is located in the basement in a room off to the west side of the boiler room. The main switchboard was replaced with the 1993 addition when the service size was increased. The gear is in good condition, but appears to be full. If there are any future additions or any large HVAC units added, additional sections will need to be added.

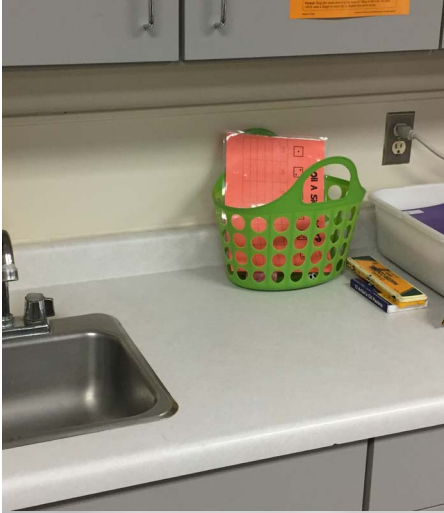
Figure 4 - Non-GFCI receptacle near sink

- Add floor cord covers in the library where there are currently extension cords that run across the floor.
- Add GFCI protection to all receptacles that are located within 6 feet of a sink to mitigate violation of the National Electric Code.

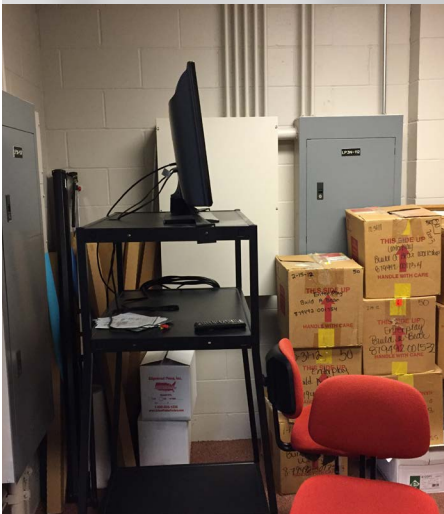
Figure 5 - Electrical panels without proper clearances maintained

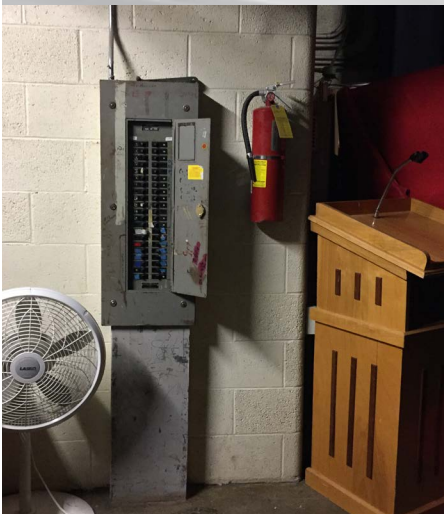
Figure 6 - Older electrical panel

The main service equipment feeds branch panels throughout the facility. Many of these panels are the newer style and in good condition, but several are original to the building. While these panels are still in working order, it may be difficult to find replacement parts for them. It is recommended that these panels be replaced if circuits in these areas need to be modified.

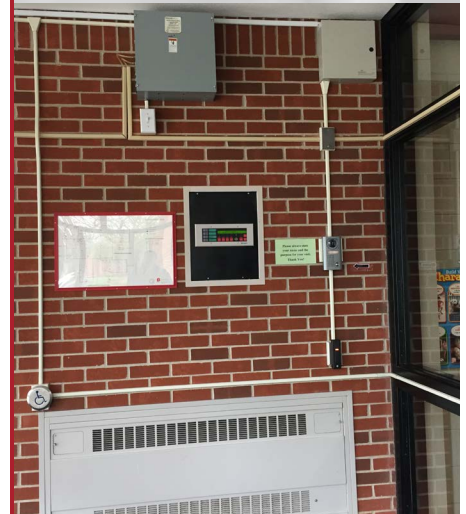
The primary building entrance is located at the northeast corner of the facility near the library (A120). Entrance doors with a power operator and insulated glass and hardware appear to be in good condition. While a call button is present, the administrative offices are located deeper into the building. Once admitted into the building, visitors must walk down the corridor unattended. While the call button and camera aid in assessment of the visitor's credibility, there is no barrier once admitted to assess the visitor's intent.

Figure 3 - Existing secured entrance

- ✓ Add additional interior and exterior cameras to improve coverage within the building and near non-monitored entrances.
- ✓ Reconfigure entrance to prevent unabated entry into the school. The school will need to determine where that lies in their risk assessment.

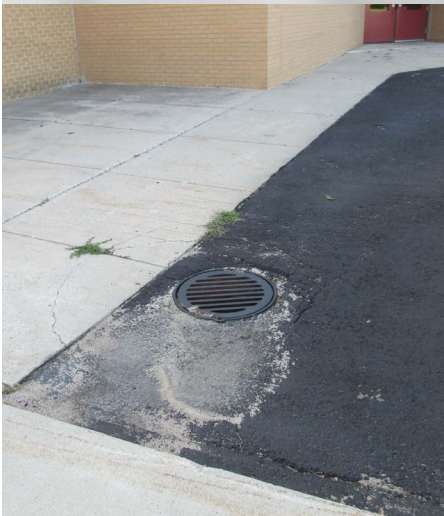
Figure 2 - Catchbasin in north staff lot

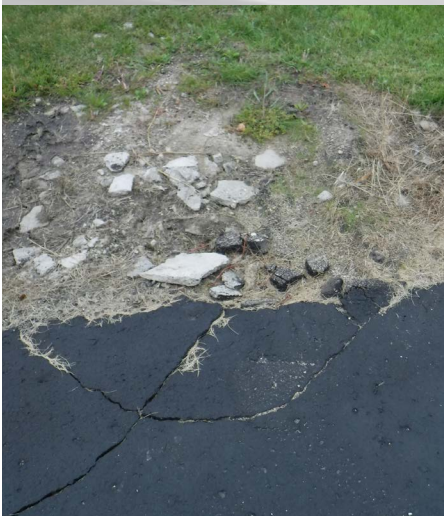
Figure 3 - Cracking bit in south staff lot

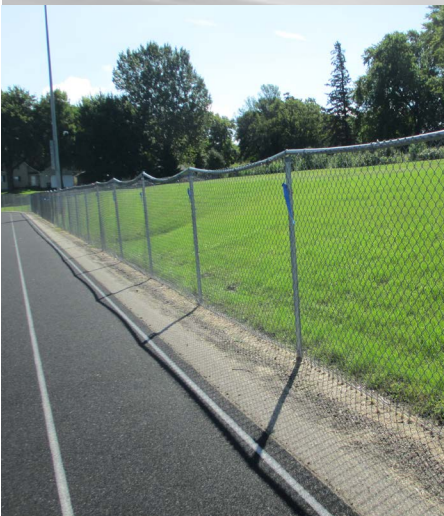
Figure 8 - Sagging fence near track

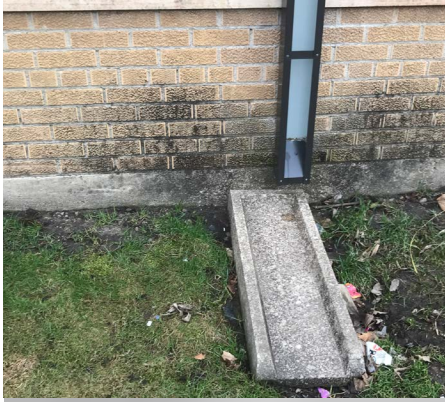
Figure 1 - Area that requires tuckpointing

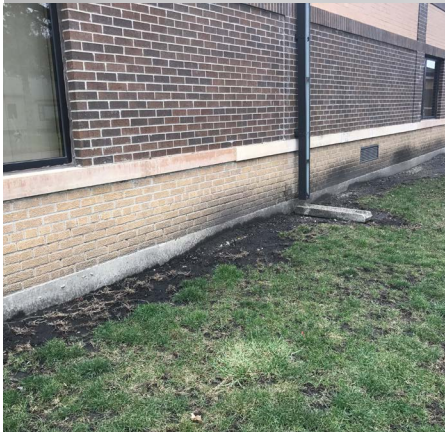
Figure 2 - Area that requires tuckpointing

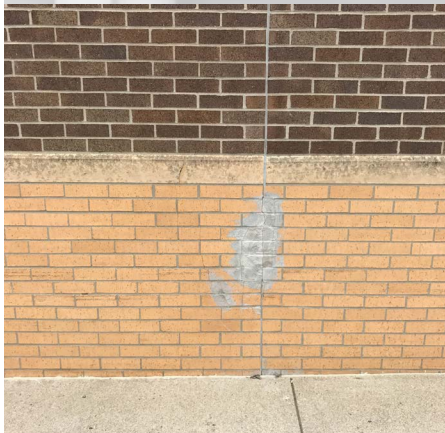
Figure 3 - Area that requires tuckpointing, sealants, or new walls

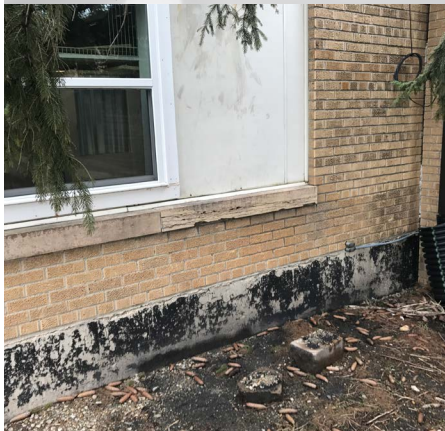
Figure 4 - Area that requires tuckpointing, sealants, or new walls

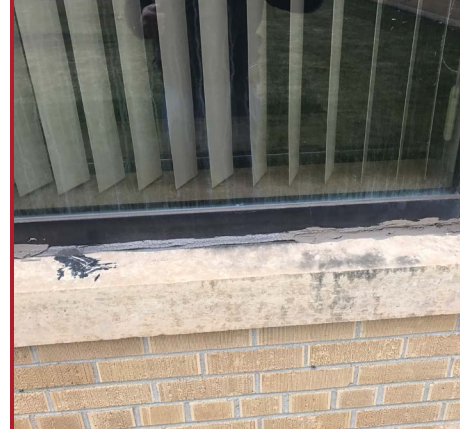
Figure 5 - Poor sealants around window frames

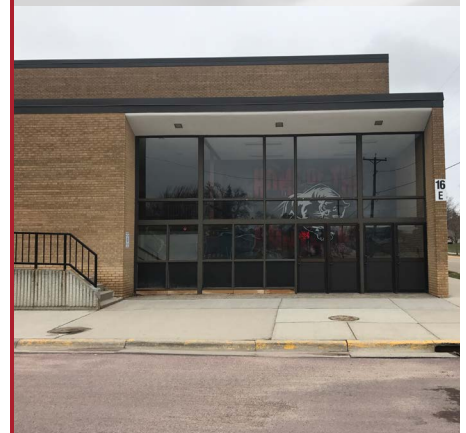
Figure 7 - Windows with seal failure and rusted frames

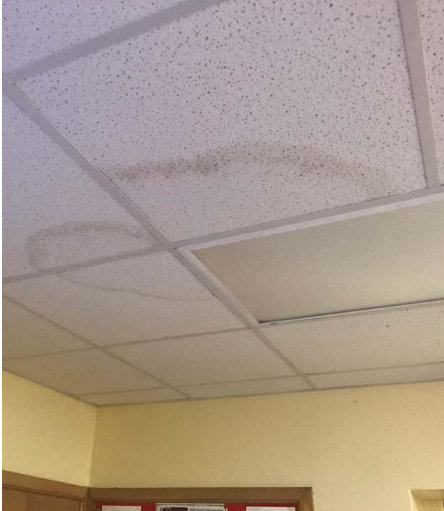
Figure 1 - Discolored ceiling tiles

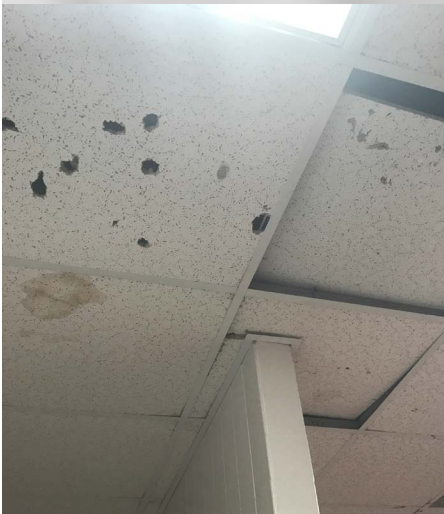
Figure 2 - Damaged ceiling in need of replacement

Ceilings in fair to poor condition which exhibited a greater percentage of physical damage and or sagging were identified in numerous locations. The first are in the locker rooms, located by the A108 gym. The boys locker room was found to be in poor condition due to vandalism. Some of the grid work was even damaged.

- ✓ Replace ceilings in the girls locker room with boys locker room requiring a complete ceiling and grid replacement. Alternative ceilings less prone to damage would be beneficial, but because ceiling access is needed, these alternatives are not a viable option. Instead, the new ceiling should try to be kept in a presentable condition. Sometimes leaving damage invites additional damage, but it seems that the school will likely need to replace these on a regular basis.

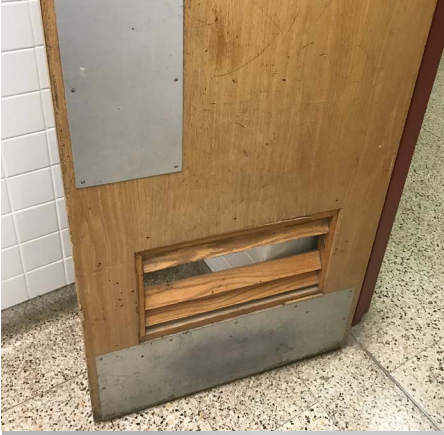
Figure 6 - Damaged air grill in door

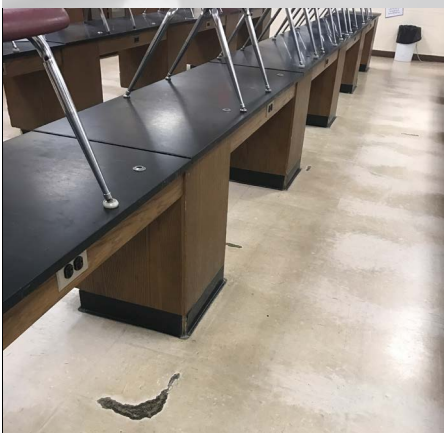
Figure 9 - Damaged floor in science area

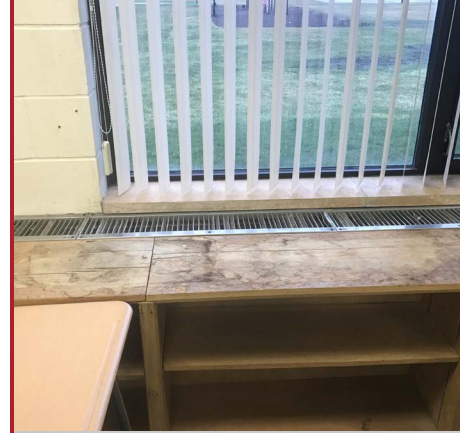
Figure 10 - Evidence of water damage to casework

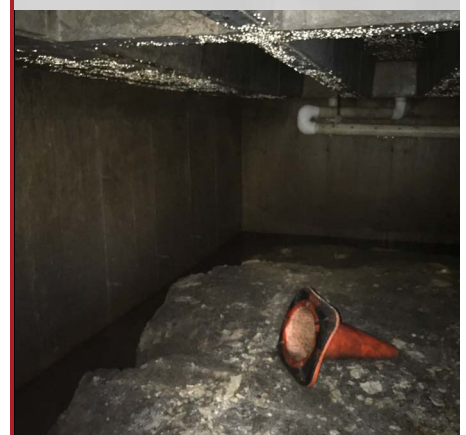
Figure 13 - Crawlspace with moisture concerns

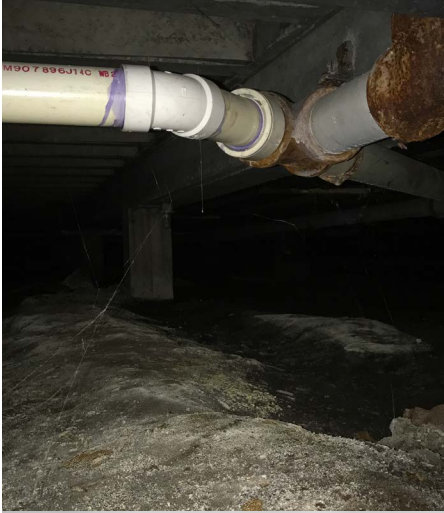
Figure 14 - Moisture concerns in unexcavated area

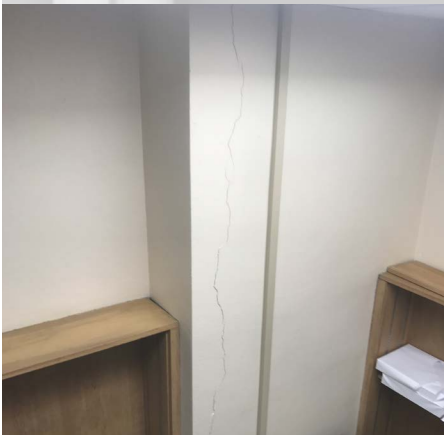
Figure 3 - Wall crack on masonry column

- Tuckpoint noted wall cracks; could also use flexible sealant. Depending on how the location responds, the remaining cracks should be repaired accordingly. Wall cracks should be monitored semi-annually, with extreme seasonal changes being the most beneficial time to review. Movement, such as differential changes in the plane of the wall or wider gaps in the crack, would be an indication something more severe is occurring and a structural engineer should evaluate the condition further. A structural engineer should be engaged to further review the column cracks in room B120.

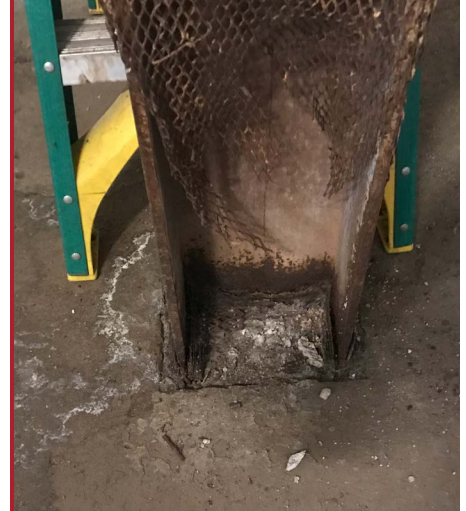
Figure 5 - Rusted and degraded column base plate in boiler room

- Reroute any drainage away from the building.
- Repair column base plates in the boiler room and coat to prevent further damage.

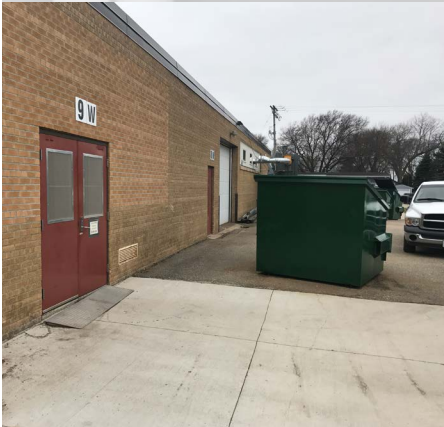
Figure 3 - Receiving room/janitor space, which lacks a dock

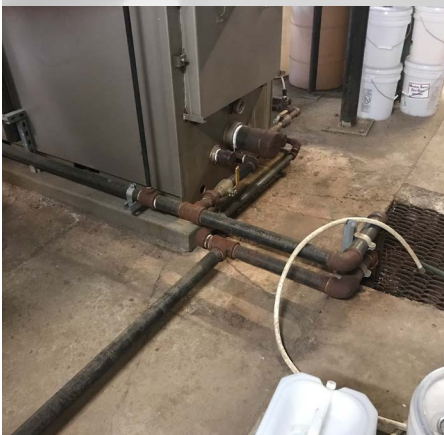
Figure 4 - Boiler room piping, creating a trip hazard

- ✓ Replace all wire glass with tempered glass.
- ✓ Replace older door in the upper commons in the north corridor during next renovation.
- ✓ Identify pipes in the boiler room with marking paints and better lighting.

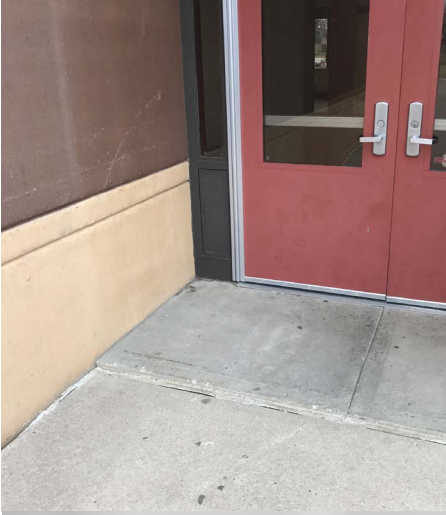
Figure 1 - Lip in concrete

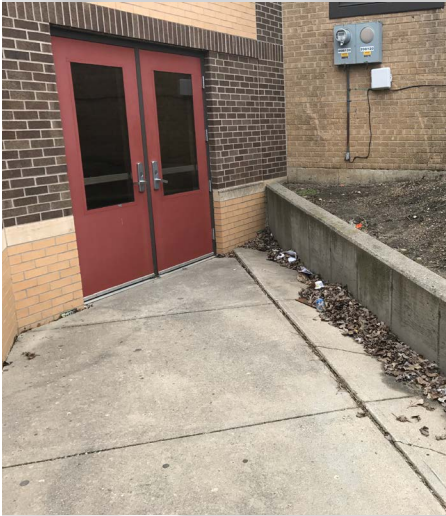
Figure 2 - Tipping sidewalk - suggests movement due to moisture intrusion

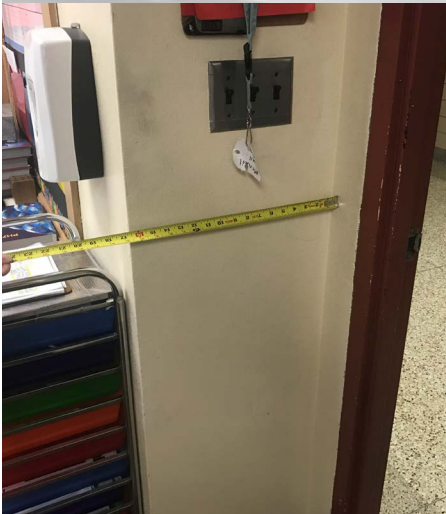
Figure 3 - Large wall depth, which is not ADA-compliant

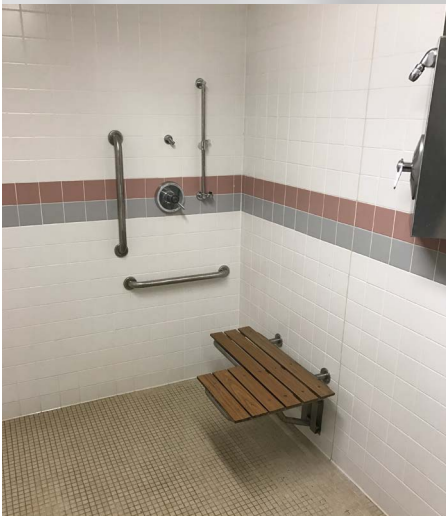
Figure 2 - Broken ADA shower

The men's and women's showers in area A off of the gymnasium had floor drains at the wrong location. Instead of having the drains on the shower's exterior, two floor drains were placed in the middle and all showers drained to them. This allows water to travel across the floor from shower to shower. Issues that were found in the men's restroom include a broken ADA shower, leaking faucets in the shower, as well as a leaking pipe in the wall. Water appeared to be coming out of the grout between the wall and the floor near the sinks. The floor was wet, and it looked like the issue was recurring. There was no pipe wrap on the sinks in this area, and there were also different faucet types on the lavatories. Some faucets are new, but most are older looking, and the finish has been removed due to an improper cleaning substance that was used. Some of the issues in the women's locker room include a broken ADA shower in addition to some shower faucets that were stuck shut and inoperable. There were also lavatories that leaked when they were turned on.

- ✓ Repair broken and leaking pipes and faucets in the men's and women's showers in area A. The older faucets could be replaced.
- ✓ Provide care to ensure that the proper floor cleanout is employed in the restrooms in area B.

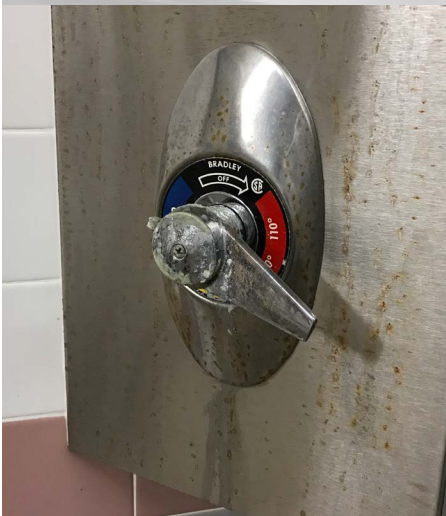
Figure 3 - Leaking shower faucet

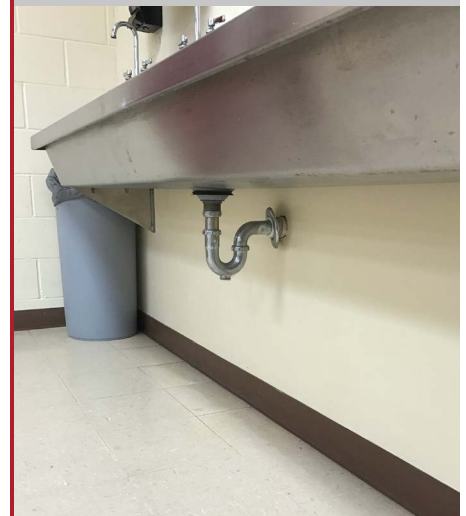
The large sink located in the art room (D153) does not have any clay traps installed below the sink. Due to the large amounts of clay and solids that can be introduced to the system, it is highly recommended to install a clay interceptor to prevent any clogging of sanitary sewer lines.

Figure 5 - Missing clay trap in art room

PRIORITY	1	2	3	4
Install clay interceptor in art room (D153) sink drain	•			
Install code compliant natural gas shut-off valve or emergency shut-off button in science area (D143 + D147)	•			
Install code compliant natural gas shut-off valve or emergency shut-off button in home economics area (E104)	•			
Replace galvanized pipe in C-wing restroom chase		•		
Repair broken ADA showers in west gym locker room		•		
Install proper floor cleanout in area B restroom group		•		
Replace galvanized pipe in C-wing classroom plumbing		•		
Install pipe wrap on p-traps in C-wing restrooms			•	
Replace leaking flush valve in women's C-wing restroom			•	
Replace poor condition sinks in C-wing classrooms			•	
Replace leaking water faucet in E124			•	
Replace filters for bottle filling water fountains			•	
Repair broken water filler in women's locker room			•	
Repair loose lavatory fixture in room D161			•	
Replace leaking water faucet in D111			•

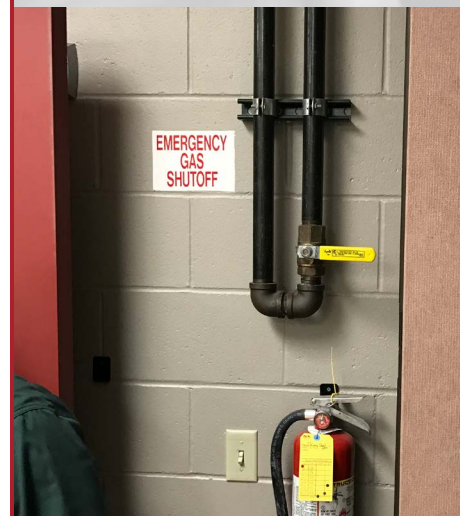
Science classroom D143 and D147 do not have a gas solenoid valve or an emergency shut-off button. The current design is a ball valve that is attached to the pipe that comes down from the ceiling to the valve, then goes back up into the ceiling. This does not meet code requirements. It was also noted that the eyewash station was not working properly. Only one eye was flowing any water. There is a thermostatic mixing valve that supplies two eye wash stations. There is a large amount of stagnant water that sits between the mixing valves and the fixtures. When testing the system, it should run long enough to flush out the pipe from the mixing valve to the fixture. If this water sits for too long, it can grow Legionella bacteria.

Figure 6 - Missing emergency gas shut-off button

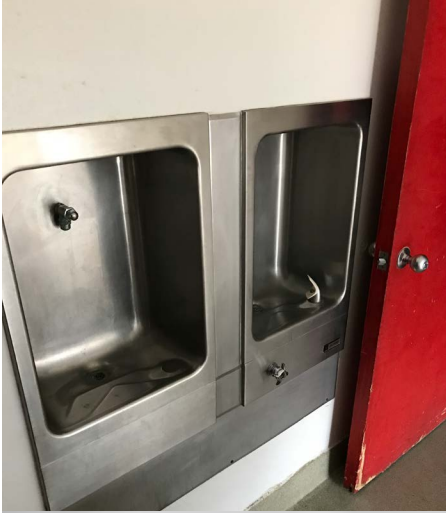
In area F, there is a drinking fountain in the stairwell leading down to the men's locker rooms that is not working. No water flow comes out of it. Several bottle fillers throughout the building have dirty filters that need replacing. The drinking fountain located in the women's locker room has a broken bottle filler. The sensor doesn't work to allow the bottle filler to function.

Figure 7 - Broken drinking fountain

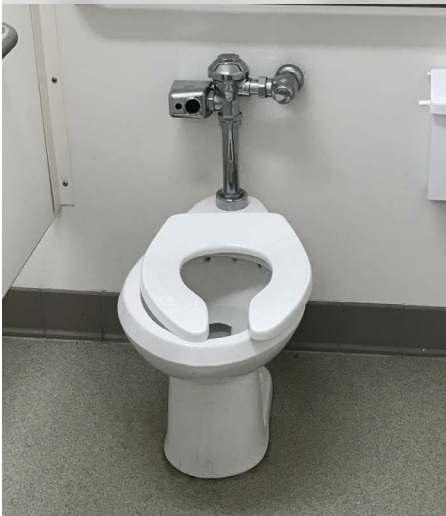
The fixtures located in the men's and women's locker/restroom below the gymnasium in area F were in bad condition. There were a couple water closets that had loose seats in addition to some leaking and loose flush valves. It was noticed that these lavatories, along with a large majority in the building, were lacking aerators on the lavatory sinks. Most were likely plugged, and then removed instead of cleaned. There is also a floor cleanout that is broken and leaving the pipe exposed to the space right below the urinal. Some of the showers didn't have proper flow. Some exterior hose bibs were in rough shape and unusable.

Figure 8 - Broken toilet seat

- ✓ Replace sinks in the nurse's room and office space need their faucets replaced. The lavatory sign in restroom D161 also needs to be rehung.
- ✓ Numerous repairs are necessary in the men's and women's locker rooms in area F to stop leaking flush valves and other broken fixtures. In the men's locker room off of the gym in area A, the ductwork requires fixing. The exhaust grille in the men's and women's restrooms in C wing also should be rebalanced.

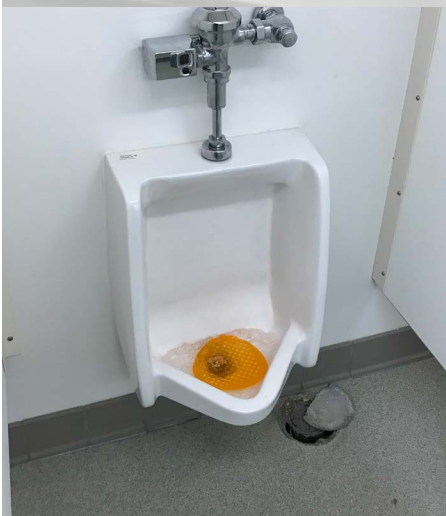
Figure 9 - Broken floor cleanout cover

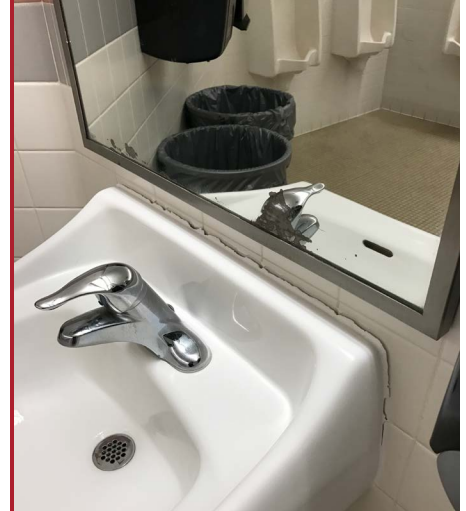
Figure 10 - Missing aerator on faucets

- ✓ Add pipe wrap throughout facility where it is missing, and the proper cleaning supplies should be utilized to ensure fixtures are not damaged.
- ✓ Clean and/or replace aerators that are missing or plugged.

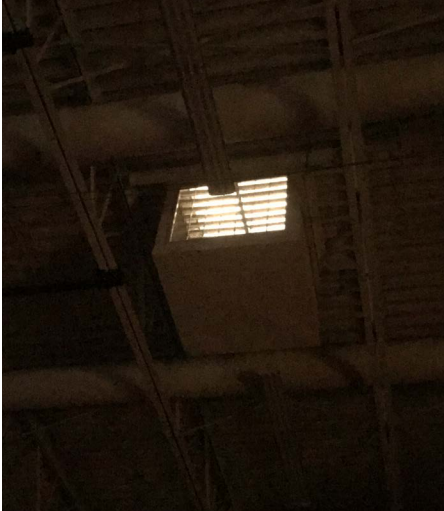
Figure 1 - Gym relief dampers stuck open

PRIORITY	1	2	3
Seal former unit ventilator wall penetrations	•		
Release stuck relief dampers for Area A gym	•		
Replace damaged diffusers in Area A gym	•		
Replace Area A gym rooftop HVAC units in poor condition	•		
Increase dishwasher hood air flow	•		
Provide ventilation to back storage room where building management system is operated	•

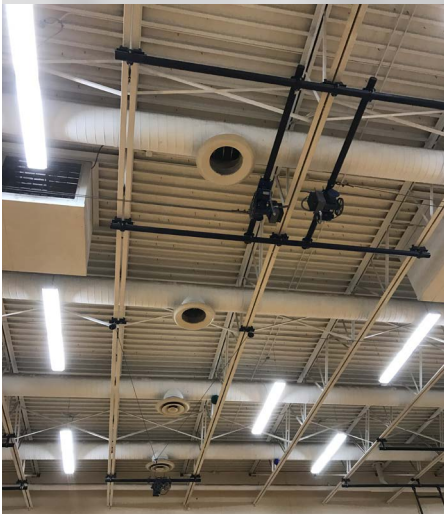
Figure 2 - Broken diffusers in gymnasium

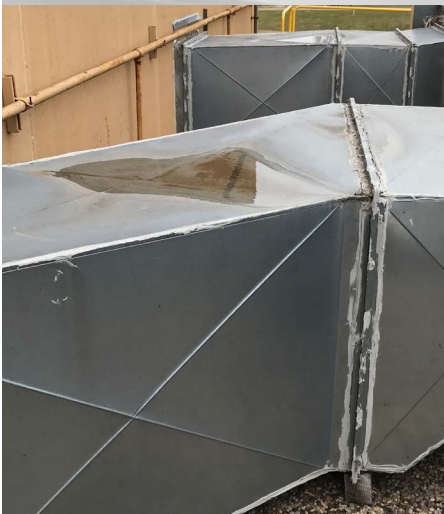
Figure 3 - Exterior ductwork not sloped properly

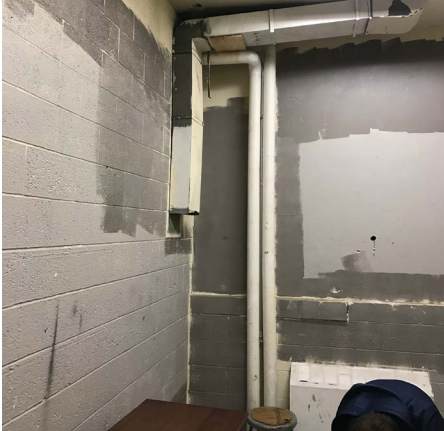
In the shop, the paint room had no exhaust or ventilation. The exhaust fan was not operating. After investigating on the roof, a broken belt inside the fan was found to be the issue. There is a brand new dust collection system that seemed to be working and in good condition.

Figure 7 - Improper exhaust flow in paint room

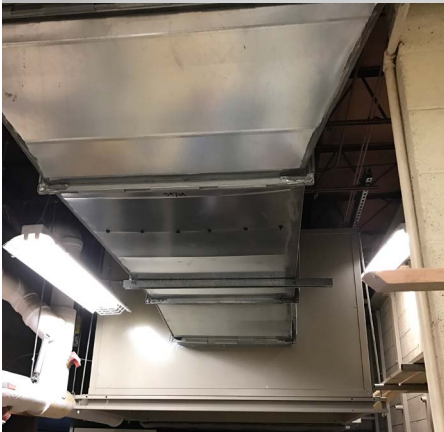
Figure 8 - No spring vibration isolation present on AHU

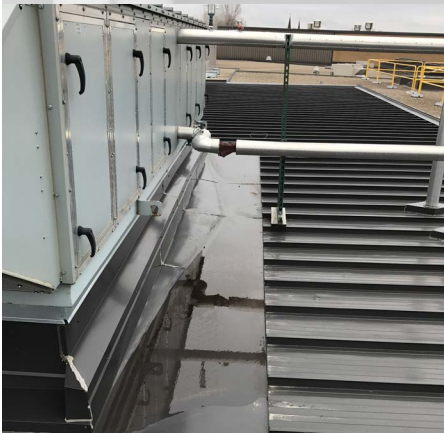
Figure 9 - Improper crickets around the RTU

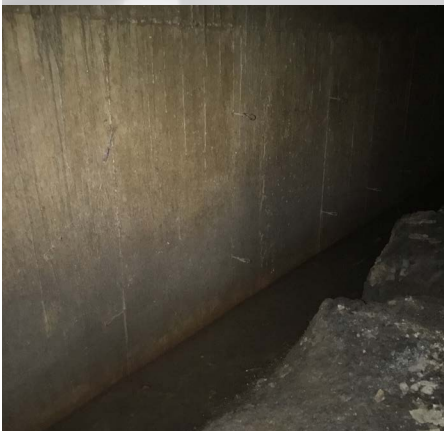
Figure 10 - Standing water in area C crawl space

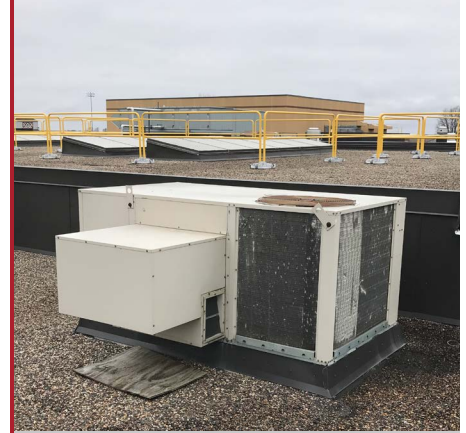
Figure 11 - Damaged condenser fins on RTU

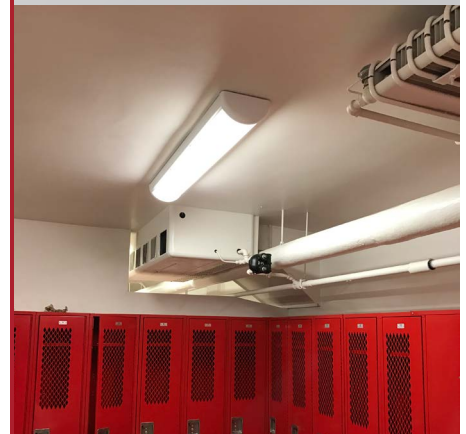
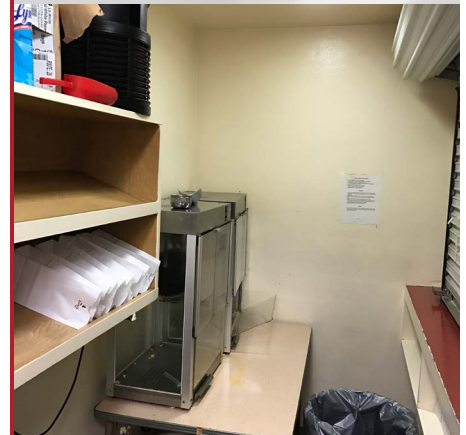
Figure 12 - Exhaust air missing in concession stand

Figure 13 - Exhaust air missing in concession stand

- ✓ Rebalance exhaust in home economics room (E104)
- ✓ Add Air movement should be added to the concession stand.
- ✓ Roof drains should be cleaned out to ensure that all standing water on the roof can drain properly and eliminate excess water. The downspouts for the roof drains also need to be cleared of any debris to ensure that they aren't blocked. Verify that all roof drains empty onto the concrete pad, so water does not erode the soil below it.

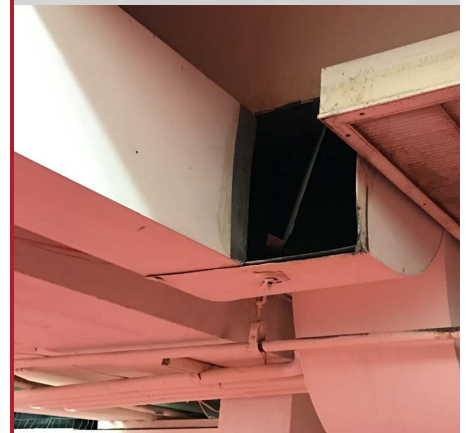
Figure 14 - Missing ductwork in wrestling room

- ✓ Ductwork should be installed in the wrestling room to ensure proper airflow and distribution for the space. It was also noted that the return grille for that space was extremely dirty.

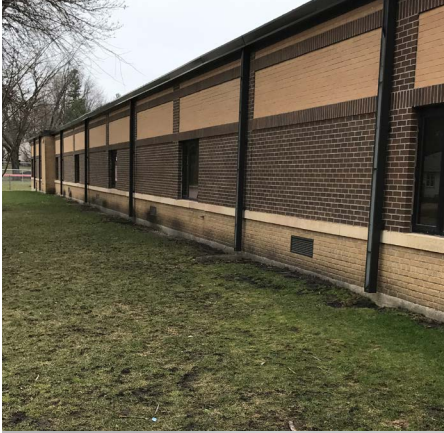
Figure 15 - Louvers low to ground

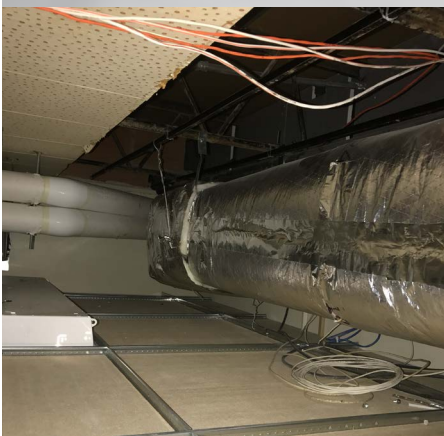
Figure 16 - Loose supply duct insulation

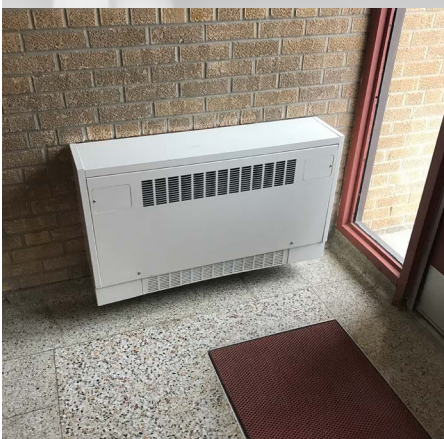
Figure 17 - CUH in vestibule in area C not working

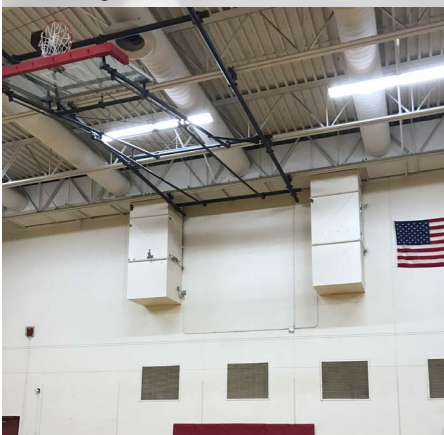
Figure 18 - Paint coming off ductwork
