NRHEG SCHOOL DISTRICT

2017 Facility Assessment

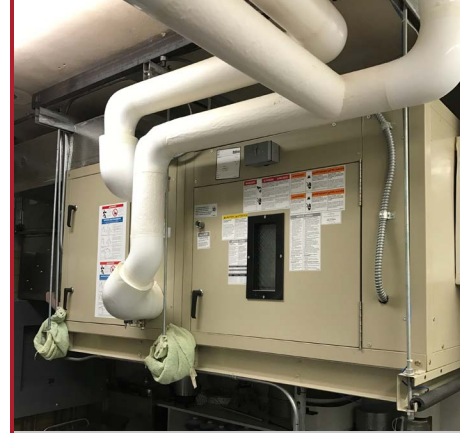
Figure 19 - Missing vibration isolation

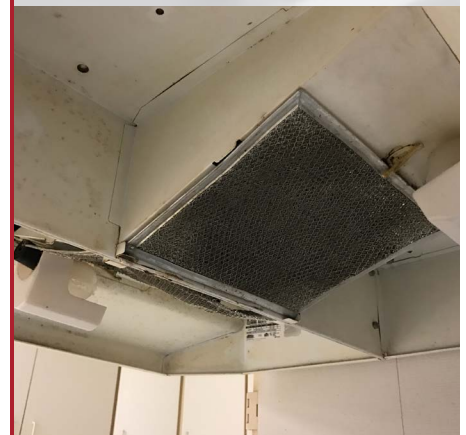
Figure 21 - Stovetop hood with no airflow

- ✓ The home economics needs to have the exhaust rebalanced. The exhaust flow rate from the kitchen hoods was extremely low. It is recommended to rebalance the system to verify that proper flow is being exhausted.

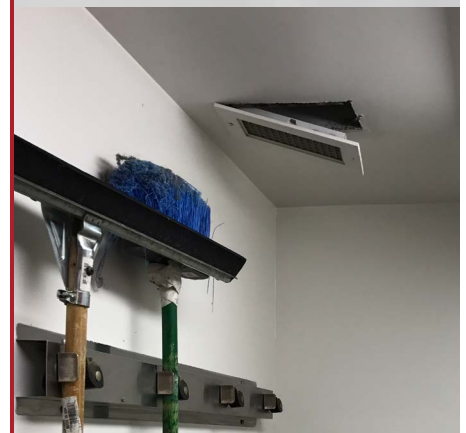
Figure 22 - Exhaust grille falling off

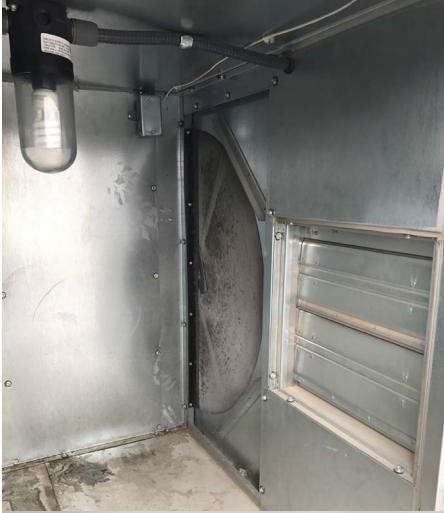
Figure 23 - Dirty energy recovery wheel

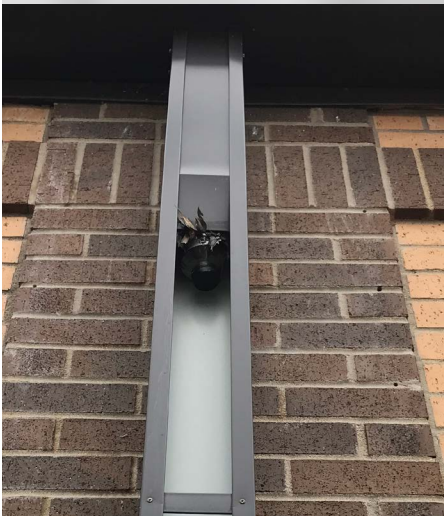
Figure 24 - Blocked roof drain

- ✓ Rebalance exhaust in home economics room (E104)
- ✓ Add Air movement should be added to the concession stand.
- ✓ Roof drains should be cleaned out to ensure that all standing water on the roof can drain properly and eliminate excess water. The downspouts for the roof drains also need to be cleared of any debris to ensure that they aren't blocked. Verify that all roof drains empty onto the concrete pad, so water does not erode the soil below it.

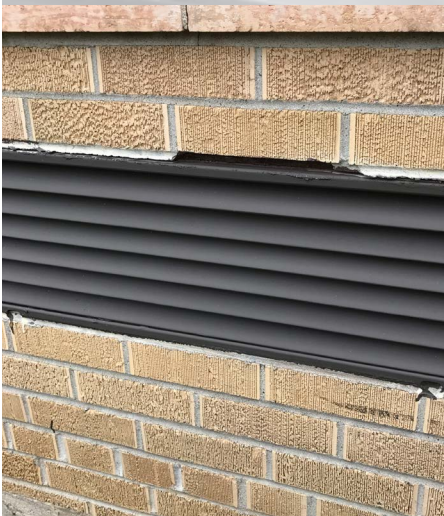
Figure 25 - Bad louver seals

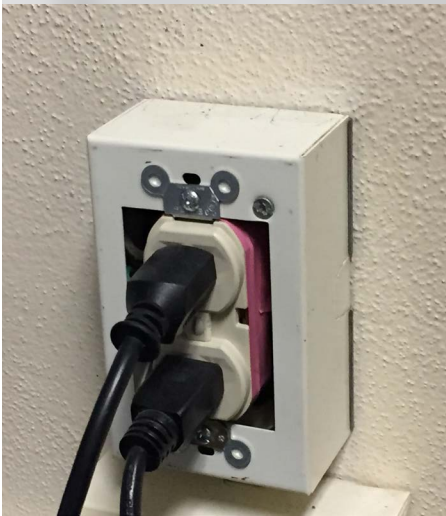
Figure 5 - Receptacle with nylon plate broken off

A lot of the existing nylon wall plates are chipped, cracked, or completely gone. This creates an electrical hazard because the live parts of the receptacle can be exposed. A few wall plates have already been upgraded to stainless steel, but there were still a lot of broken nylon plates in the facility which should be replaced with stainless steel wall plates. The surface-mounted receptacles in the gymnasium have also seen a lot of abuse.

- ☑ Recommend that above items be replaced and an impact-resistant cover be added to prevent future damage.

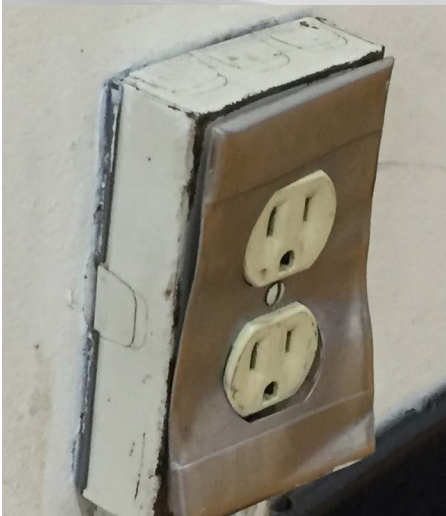
Figure 6 - Damaged receptacle in gymnasium

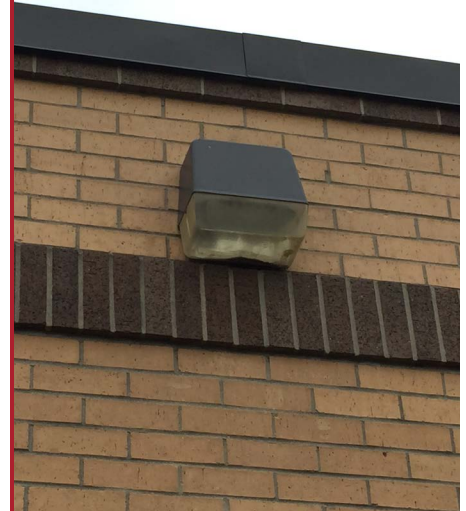
The exterior lighting is served by building-mounted HID fixtures located around the facility. HID fixtures are known for their high lighting outputs, but they are not the most energy efficient. The lights could be replaced with more energy efficient LED fixtures to reduce energy usage. Most of the fixtures appear to be in good working condition. Exterior lighting is controlled by fixture mounted photocells, which turn the fixtures on during hours of low light levels.

Figure 7 - Existing exterior HID light

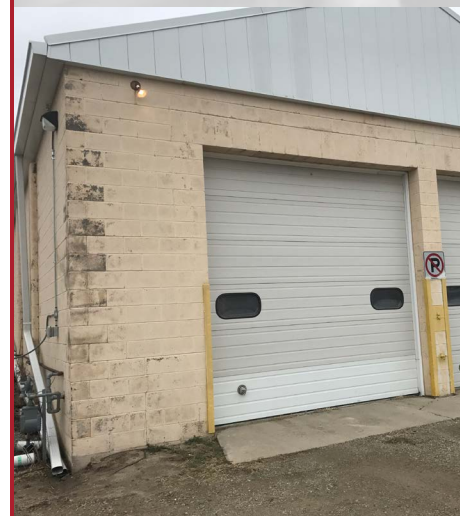
Figure 3 - Exterior paint peeling
