NRHEG SCHOOL DISTRICT

2017 Facility Assessment

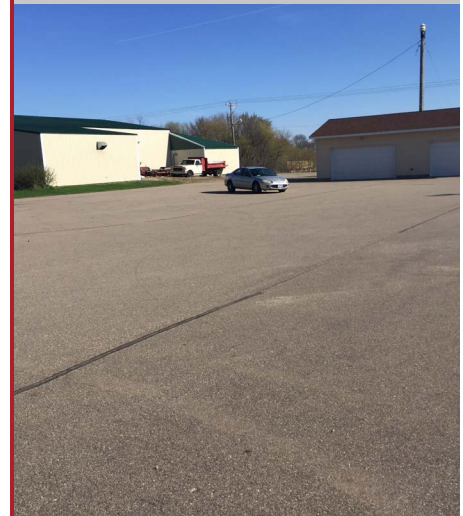
The staff parking lot is located southwest of the student pick-up and drop-off lot. Staff enter and exit the lot from 8th Avenue West. The parking lot is striped to indicate a one-way orientation, with the east driveway serving as an entrance and west drive serving as an exit. The striping within the lot is very faded which can cause confusion of the designated drive aisles and parking areas.

Due to the severely faded lot striping, the exact parking count in the staff lot is unclear. A general rule for minimum elementary school parking spaces is 1 stall per employee, plus 10 visitor spaces. With approximately 28 staff members, a total of 38 parking stalls are recommended. Together, the school's parking areas exceed these recommendations.

Figure 5 - Faded staff parking

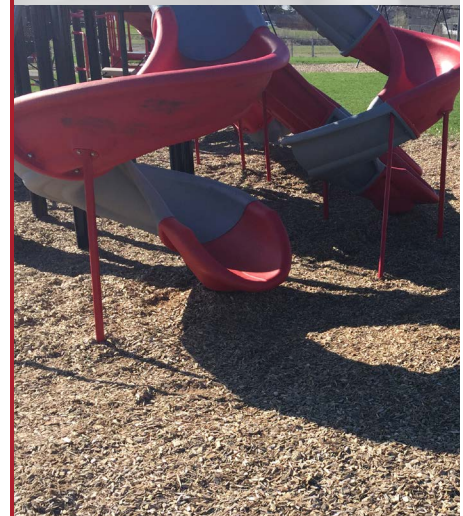
Figure 6 - Playground and mulch

The north play area consists of 8 pieces of equipment and a wood chip surface. The equipment showed some signs of weathering, however no areas of rust or deficiencies were observed. The wood chip surfacing was spread outside of the designated area creating sections of thin to no wood chip coverage.

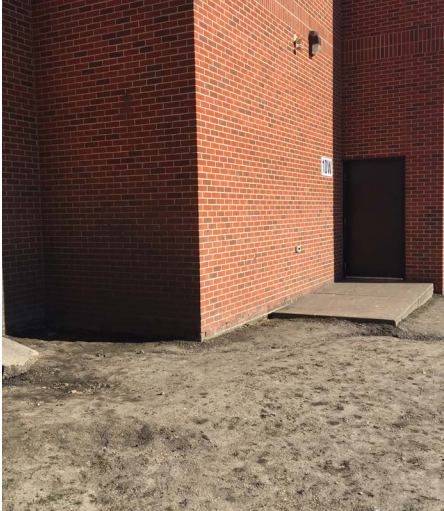
Figure 7 - Erosion

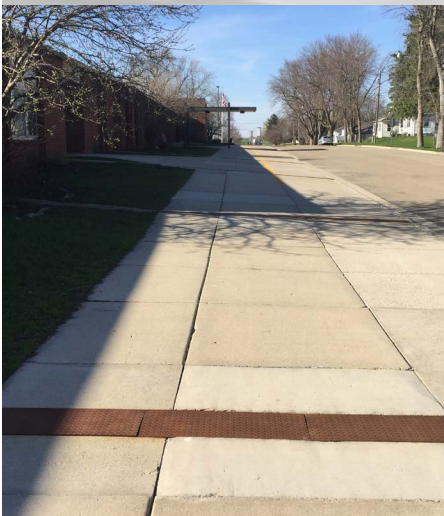
Drainage from the roof is directed through concrete channels and flows into trench drains through the sidewalk into the street. The trench drains have solid tops and are in fair condition. Indications of rust and warping are causing the grates to not lay flat.

Figure 9 - Warped grates

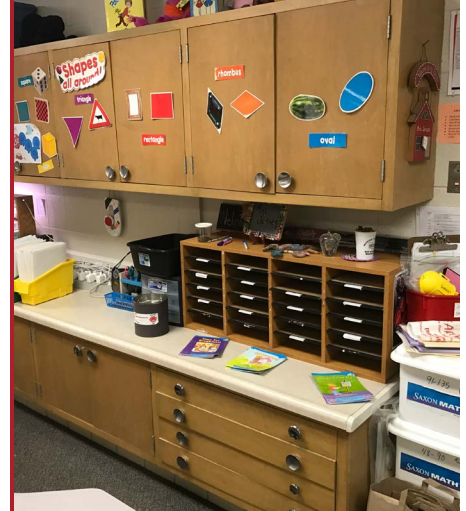
Figure 1 - Classroom casework

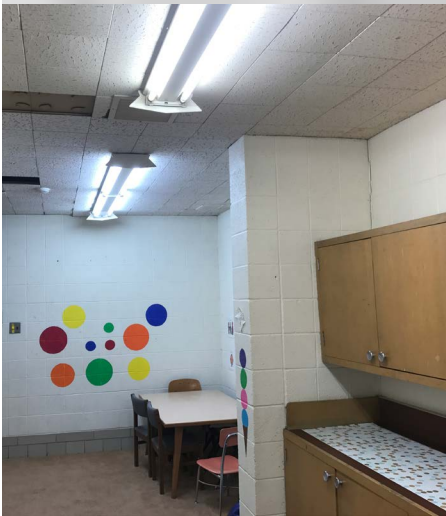
Figure 5 - Typical casework

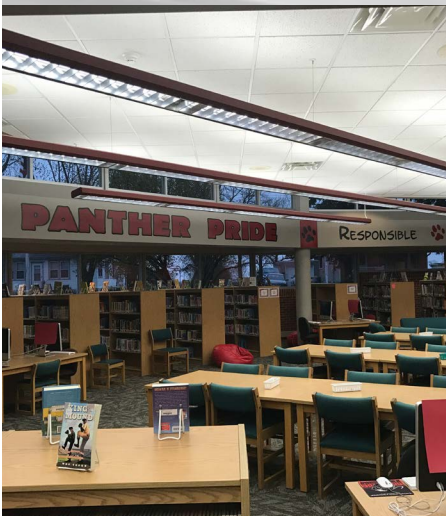
Figure 6 - Library with residential-style cabinetry

Upper cabinets in the library are of a residential style, and the bottoms are beginning to sag after being subjected to more rigorous conditions than they would typically be designed to accommodate.

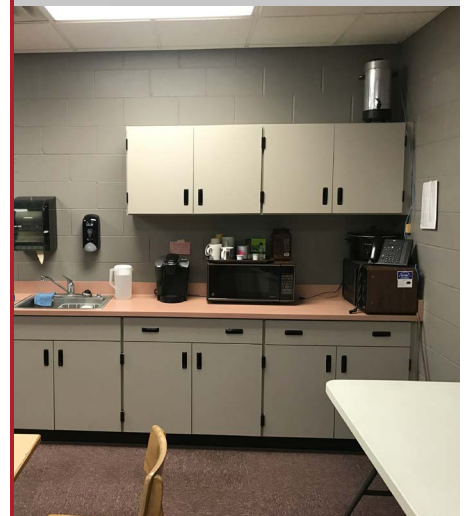
Figure 8 - Staff lounge

- ✓ Refinish south wall in classroom B115
- ✓ Replace floors in the music room and adjoining practice rooms.
- ✓ Adjust arrangement of the staff lounge.
- ✓ Repair toilet partition doors in the boys and girls restrooms.

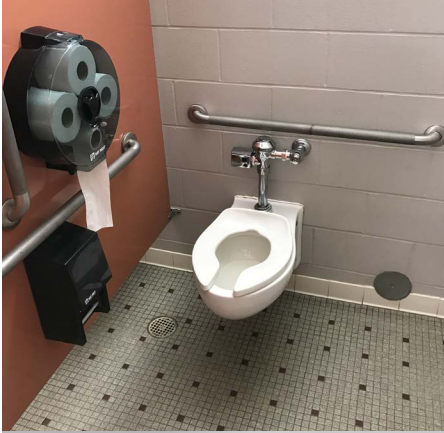
Figure 1 - Handicapped restroom stall

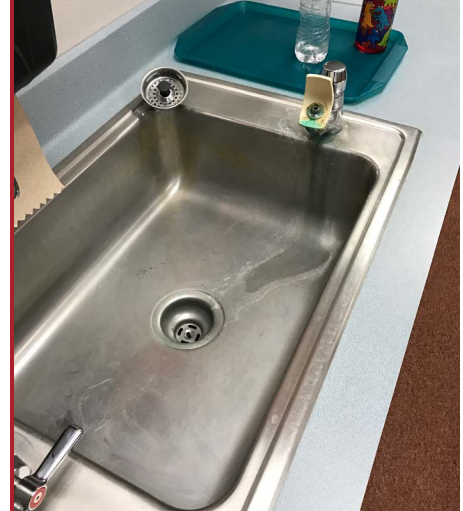
Figure 1 - Leaking faucets

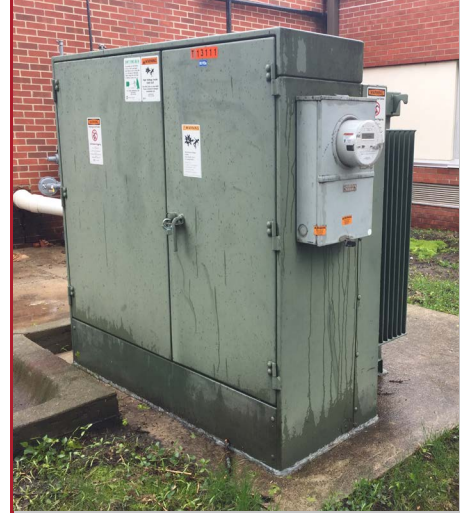
Figure 1 - Ground-mounted transformer

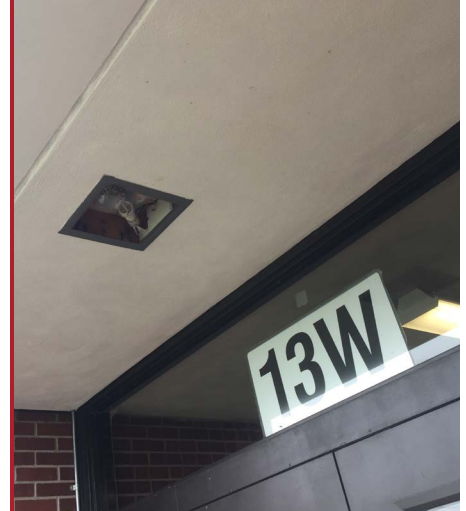
The interior lighting fixtures have been upgraded with linear fluorescent T8 light bulbs. While a majority of the light fixtures are in good to fair condition, a few fixtures do have warped or broken lenses.

Figure 7 - Light with broken lens

- Replace warped or broken lenses on light fixtures.
- Replace HID fixtures with more energy efficient LED fixtures to reduce energy usage and improve aesthetics.

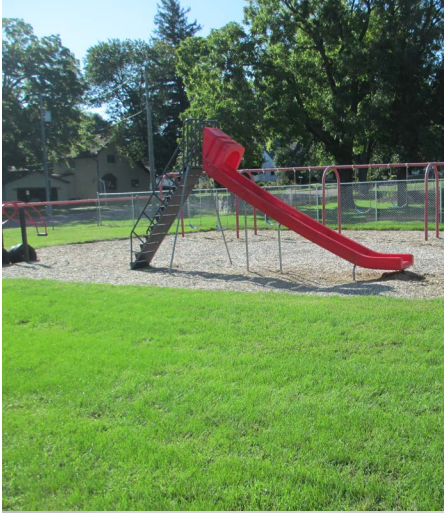
Figure 6 - Faded playground

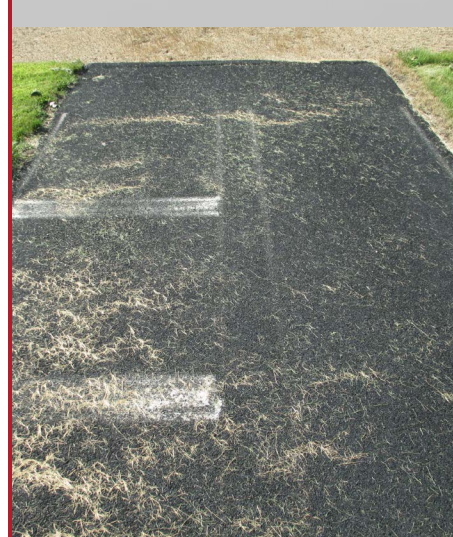
Figure 10 - Faded track runway stripe

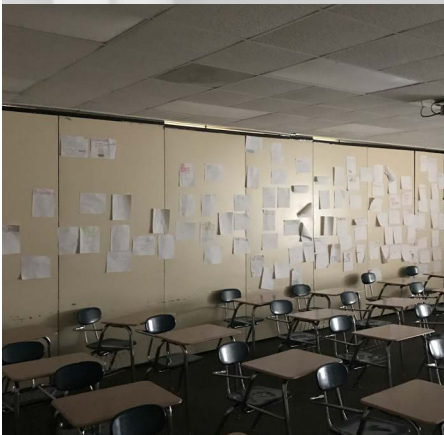
The folding wall door in Room D105A and B does not operate and has sound transfer issues. The door has gaps that contribute to the sound transfer. If the folding wall is not

Figure 8 - Movable wall unit

deemed important, it would be more cost effective to remove the door and install a permanent wall in its place. Electrical and data outlets could be added as well.

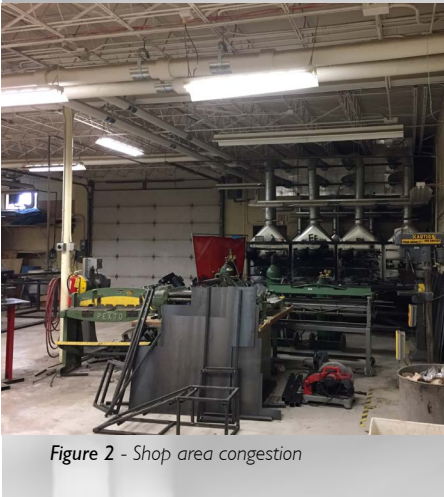
Figure 2 - Shop area congestion

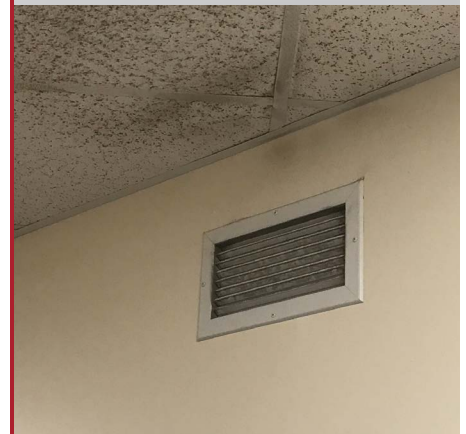
Figure 20 - Transfer grill for kitchen

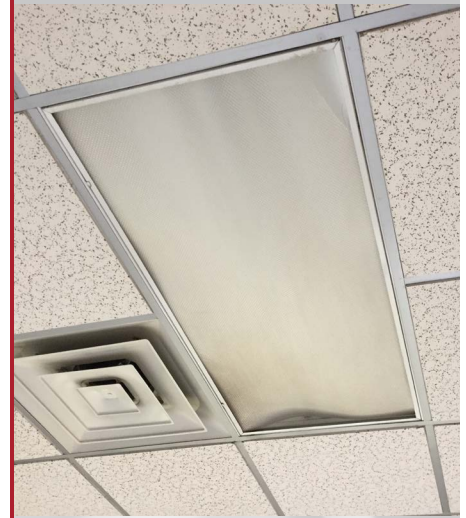
Figure 8 - Light fixture with warped lens

- ☑ Perform an electrical study to analyze short circuit fault currents, protective device coordination, and arc flash hazards. After the study, the electrical panels can then be labeled with the correct information. The study should be performed prior to purchasing any new equipment to ensure it is properly rated for the available short circuit fault current.
- ☑ Replace football field backboard and add adequate footings. The bus garage panelboard should also be replaced, as it has missing pieces and broken breakers, and finding replacement parts will be difficult.
- ☑ Add new lighting in the bus garage.
- ☑ Replace light fixtures that have warped or broken lenses, especially in the junior high locker rooms.

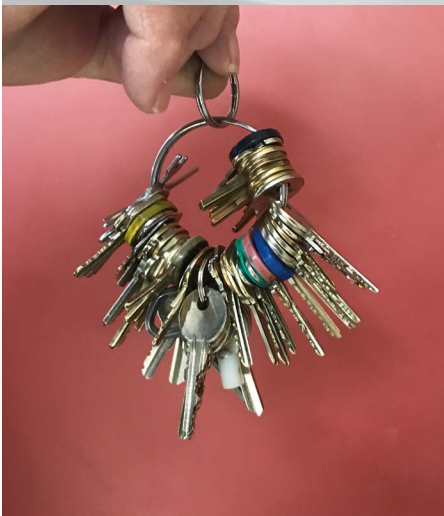
Figure 3 - Current custodial staff key ring

- Add more cameras to improve coverage in the building, as well as adding exterior cameras near all entrances.
- Change over to a master key or card readers system.

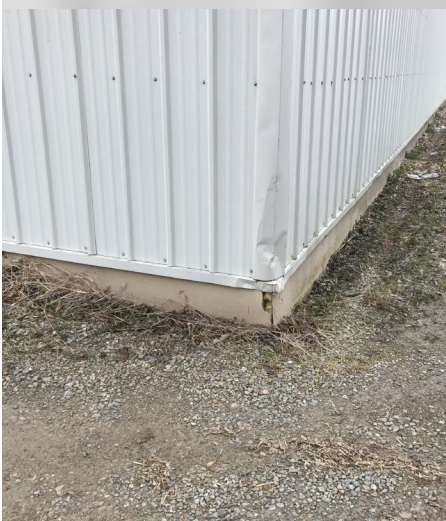
Figure 5 - Foundation isolation
